## 11.3 Characterization of Fractured Bedrock, United Kingdom

### HRSC Targets Impacts

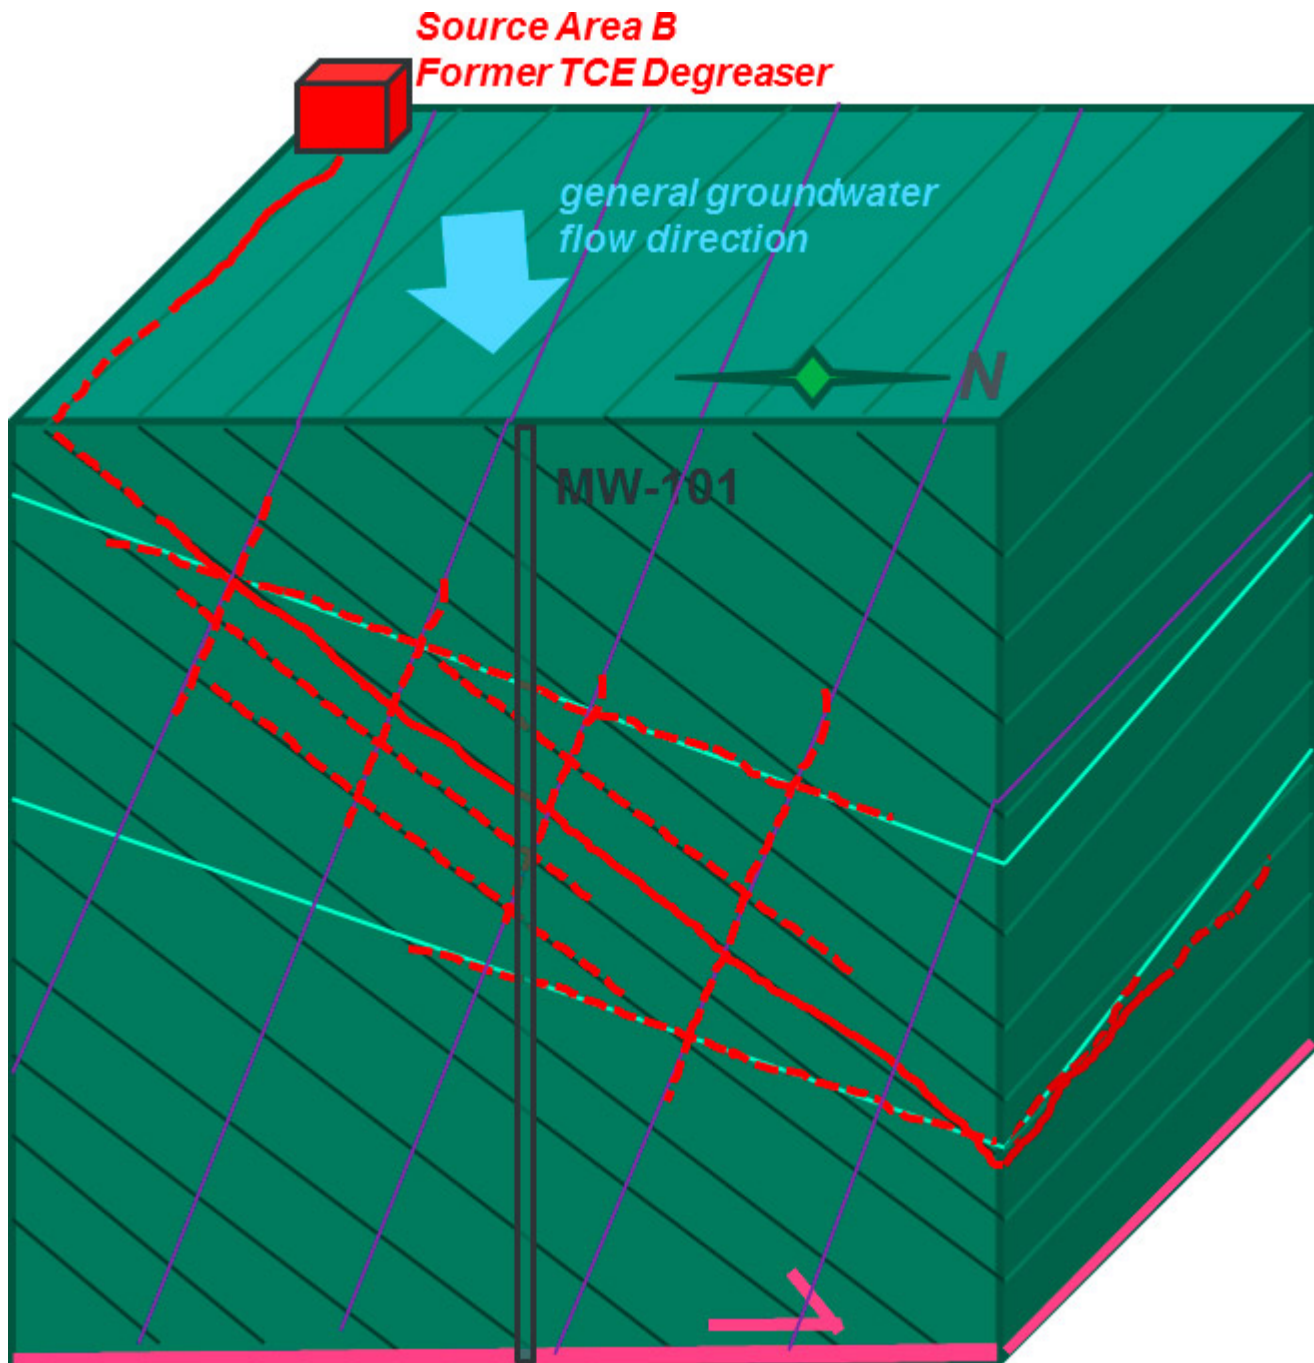
**Figure 11-13. Fractured bedrock structural features for study site.**

Note that the green parallel lines are bedding and bed parallel fractures (dipping 45°N), purple are slaty cleavage (dipping 60°S) and pale blue are a low angle open fracture set (dipping 30°N). The thrust is schematically illustrated as the pink line. TCE impacts in fractures are schematically indicated in red lines, solid to indicate >10% solubility, dashed to indicate lower concentrations in dissolved phase.

The results of the acoustic televiewer, structural logging and frequency analysis and the Core DFN data allowed orientated structural features, such as fractures and bedding planes to be compared with TCE distribution to develop a fractured bedrock CSM. The fractured bedrock structural features are shown in Figure 11-13.

- bed parallel fractures: frequent (1 or 3 per m), open (typically submillimeter aperture or microfractures) present almost throughout, but particularly on the upper limb of the fold-thrust structure between 16-36m bgl, where frequency was around 4 to 8 /m
- regional slate cleavage: common, high angle fractures (typically 0.2 to 1 /m), either tight or open (again, submillimeter aperture)
- low-angle open fractures: rarer (< 0.2 /m), typically open (around 1 mm aperture) and may be related to surface unloading
- veins: variable frequency, occurring in clusters of up to 8/m (steep, narrow vein sets were usually fully cemented and tight, while the lower angle veins were vuggy with discontinuous apertures up to several millimeters)

The synthesis of the Core DFN data and the structural analysis indicates that TCE migration from potential sources is along both bed parallel and slate cleavage fractures. Both these structures strike approximately east-west, but dip in opposite directions, and are both cut by rarer low angle open fractures. This condition has produced a highly connected fracture network mesh, allowing a dissolved phase plume to travel down the hydraulic gradient.

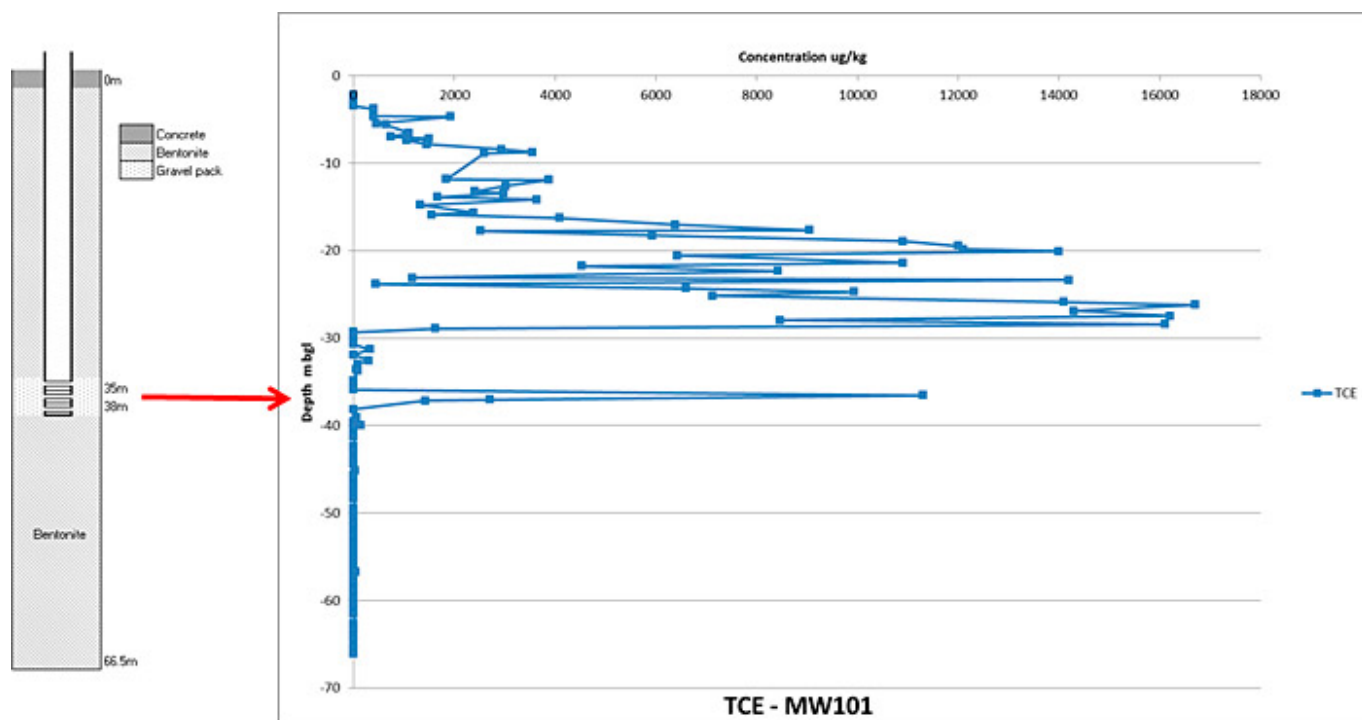
**Figure 11-15. Vertical contaminant profile and targeted monitoring well installation.**

The use of Core DFN and analysis of rock samples using an on-site laboratory allowed the depths of TCE impact to be identified in near real-time. Rapid access to laboratory results informed decision making about drilling depth. Borehole drilling was then terminated once into 'clean' strata, reducing the operational drilling time spent on site. The first borehole drilled was advanced approximately 25 m into clean strata to confidently prove the maximum depth of impacts and this information was used to facilitate the earlier termination of subsequent monitoring wells, which were terminated less than 10 m into clean strata. In all cases, the base of the drilled boreholes was installed with a competent bentonite seal to prevent further downward contaminant migration and targeted monitoring wells were installed within contaminant transport zones (coincident with fractures). Figure 11-15 shows the vertical contaminant profile detected within the first borehole drilled, alongside the targeted monitoring well that was installed. In the case of this borehole, the decision was made to install a monitoring well targeting the high TCE concentrations detected at 37 m bgl, which corresponded with the location of

a major fracture identified by the Core DFN and acoustic televiewer. The fractures with high concentrations located between 20-25 m bgl had also been targeted by an adjacent monitoring well installed during the preliminary site investigation in April 2015.

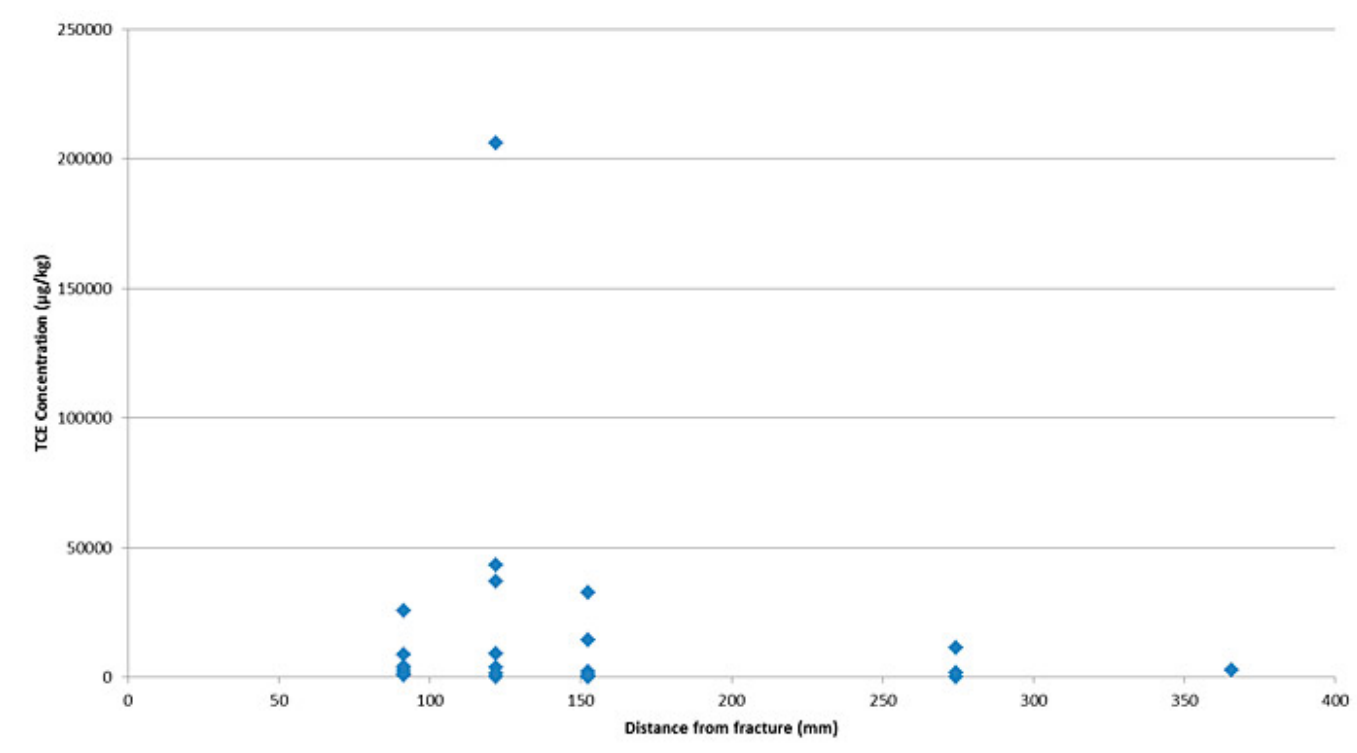
**Figure 11-16. Plot showing TCE concentration in rock (µg/kg) vs distance of sample from fracture surface.**

During the HRSC investigation, a total of 351 Core DFN rock samples were collected from a total of 186.8 m of linear rock cores, across four borehole locations. All samples were analyzed on site for VOCs. To further assist in interpretation, samples were also analyzed for physical properties (porosity, % moisture, bulk density) allowing the calculation of porewater concentrations. Comparison of porewater concentrations with groundwater concentrations indicates that elevated concentrations of TCE are present within the groundwater and fracture network and are also present within the rock matrix. Of the 351 samples collected, the majority were collected from fracture surfaces and located either immediately above or below a fracture. Furthermore, 73 samples were collected within the rock matrix away from fractures and of these, 30 contained concentrations of TCE above the laboratory limit of detection (LOD). Assessment of the 30 matrix samples with detections above LOD against the distance of these samples from the fracture surfaces suggests that TCE impacts have diffused a maximum of 365 mm into the slate bedrock matrix. This information suggests that TCE contained within the rock matrix represents a potential secondary source of contamination. The implications of the secondary source is considered as part of the remedial options appraisal for the site. Concentrations of TCE as determined via Core DFN and sample distance from a fracture surface are plotted in Figure 11-16.
