## 11.3 Characterization of Fractured Bedrock, United Kingdom

### HRSC Targets Impacts

*High resolution site characterization (HRSC) enabled a targeted site investigation that delineated the depths of TCE impacts in near real time (optimizing drilling meterage) and demonstrated the presence of this solvent both within the fractures and diffused into the rock matrix. This information is critical to fully understand the CSM, improve remediation performance, and gain agreement of endpoints with the regulatory authorities in line with the client's objectives.*

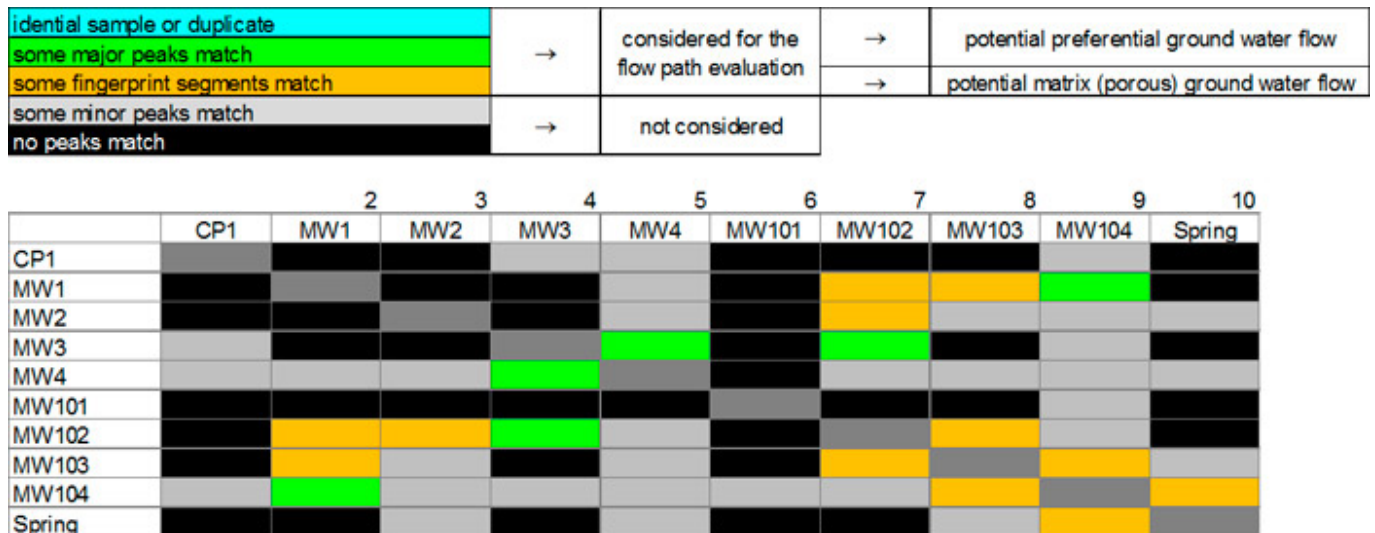
**Figure 11-14. Background fluorescence analysis results.**

The BFA identified potential hydraulic connections between monitoring wells located on the site and between the site and third party off-site receptors, as indicated in Figure 11-14. BFA uses the fluorescent properties of the organic content of groundwater samples to develop well-specific fingerprints, which are subsequently compared to predict potential hydraulic connections. The potential hydraulic connections identified support the likely TCE migration pathways identified within the fractured bedrock CSM and demonstrate the complexity of the subsurface.

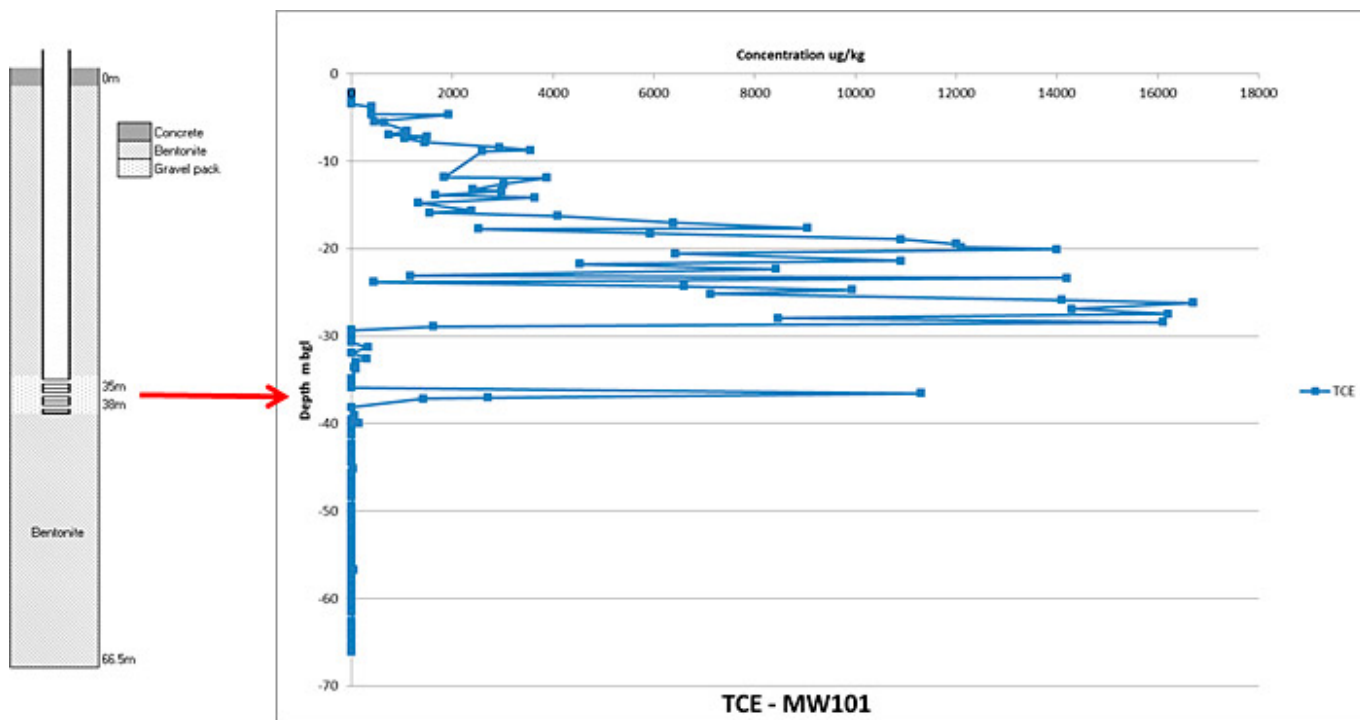
**Figure 11-15. Vertical contaminant profile and targeted monitoring well installation.**

10 m into clean strata. In all cases, the base of the drilled boreholes was installed with a competent bentonite seal to prevent further downward contaminant migration and targeted monitoring wells were installed within contaminant transport zones (coincident with fractures). Figure 11-15 shows the vertical contaminant profile detected within the first borehole drilled, alongside the targeted monitoring well that was installed. In the case of this borehole, the decision was made to install a monitoring well targeting the high TCE concentrations detected at 37 m bgl, which corresponded with the location of a major fracture identified by the Core DFN and acoustic televiewer. The fractures with high concentrations located between 20-25 m bgl had also been targeted by an adjacent monitoring well installed during the preliminary site investigation in April 2015.

The use of Core DFN and analysis of rock samples using an on-site laboratory allowed the depths of TCE impact to be identified in near real-time. Rapid access to laboratory results informed decision making about drilling depth. Borehole drilling was then terminated once into ‘clean’ strata, reducing the operational drilling time spent on site. The first borehole drilled was advanced approximately 25 m into clean strata to confidently prove the maximum depth of impacts and this information was used to facilitate the earlier termination of subsequent monitoring wells, which were terminated less than

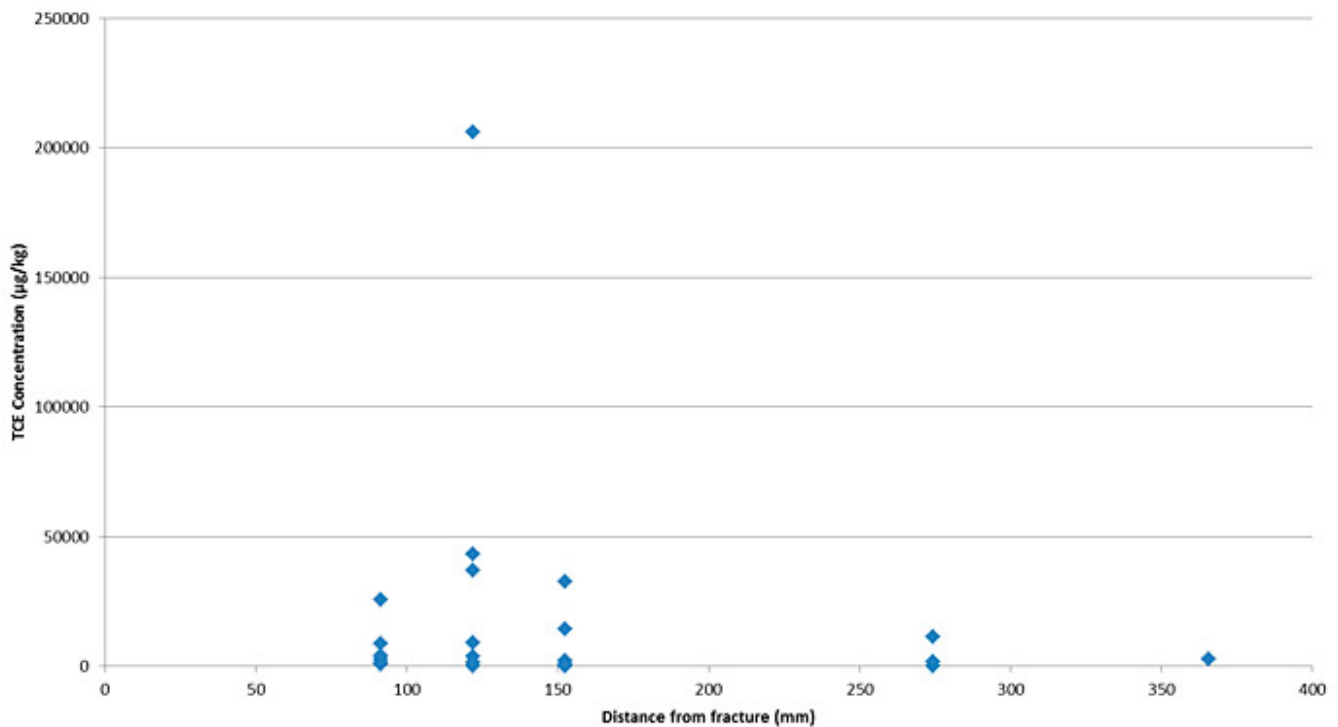
**Figure 11-16. Plot showing TCE concentration in rock (µg/kg) vs distance of sample from fracture surface.**

Of the 351 samples collected, the majority were collected from fracture surfaces and located either immediately above or below a fracture. Furthermore, 73 samples were collected within the rock matrix away from fractures and of these, 30 contained concentrations of TCE above the laboratory limit of detection (LOD). Assessment of the 30 matrix samples with detections above LOD against the distance of these samples from the fracture surfaces suggests that TCE impacts have diffused a maximum of 365 mm into the slate bedrock matrix. This information suggests that TCE contained within the rock matrix represents a potential secondary source of contamination. The implications of the secondary source is considered as part of the remedial options appraisal for the site. Concentrations of TCE as determined via Core DFN and sample distance from a fracture surface are plotted in Figure 11-16.

During the HRSC investigation, a total of 351 Core DFN rock samples were collected from a total of 186.8 m of linear rock cores, across four borehole locations. All samples were analyzed on site for VOCs. To further assist in interpretation, samples were also analyzed for physical properties (porosity, % moisture, bulk density) allowing the calculation of porewater concentrations. Comparison of porewater concentrations with groundwater concentrations indicates that elevated concentrations of TCE are present within the groundwater and fracture network and are also present within the rock matrix.
