11.3 Characterization of Fractured Bedrock, United Kingdom

Site Description

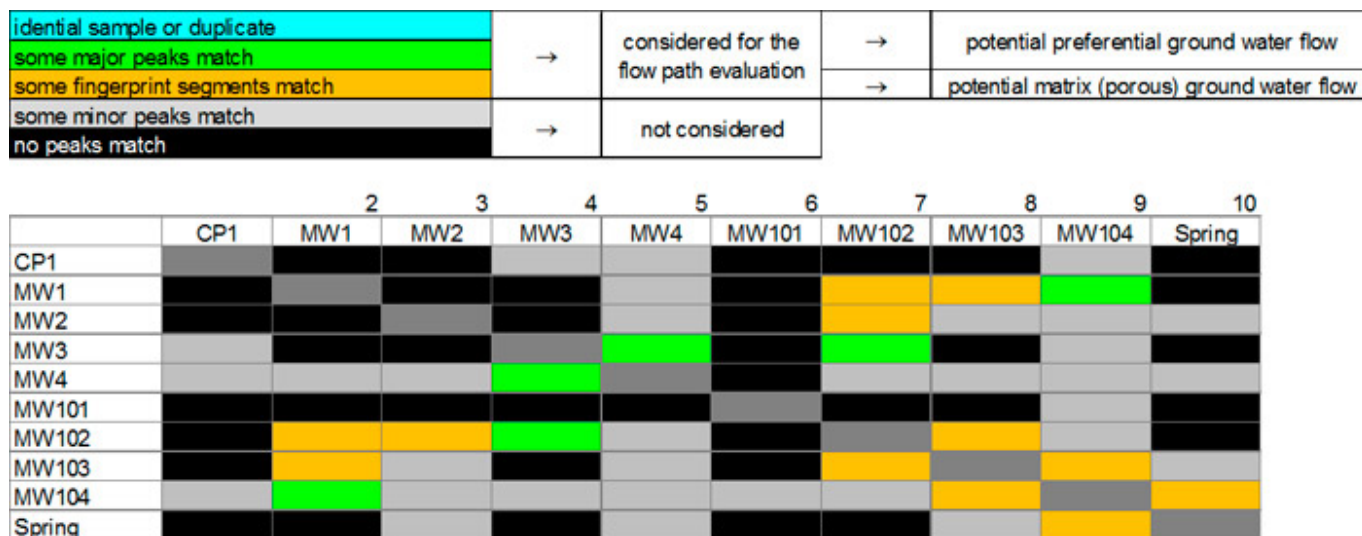
Figure 11-14. Background fluorescence analysis results.

The BFA identified potential hydraulic connections between monitoring wells located on the site and between the site and third party off-site receptors, as indicated in Figure 11-14. BFA uses the fluorescent properties of the organic content of groundwater samples to develop well-specific fingerprints, which are subsequently compared to predict potential hydraulic connections. The potential hydraulic connections identified support the likely TCE migration pathways identified within the fractured bedrock CSM and demonstrate the complexity of the subsurface.

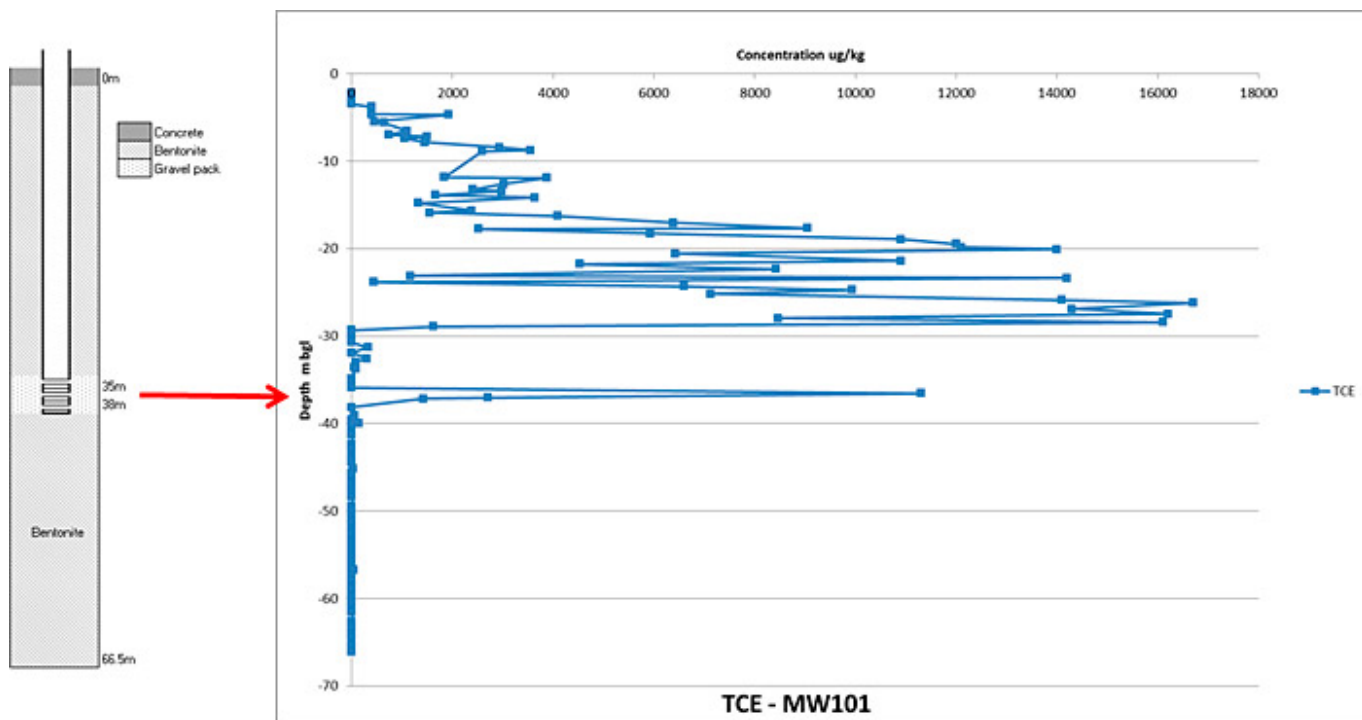
Figure 11-15. Vertical contaminant profile and targeted monitoring well installation.

The use of Core DFN and analysis of rock samples using an on-site laboratory allowed the depths of TCE impact to be identified in near real-time. Rapid access to laboratory results informed decision making about drilling depth. Borehole drilling was then terminated once into 'clean' strata, reducing the operational drilling time spent on site. The first borehole drilled was advanced approximately 25 m into clean strata to confidently prove the maximum depth of impacts and this information was used to facilitate the earlier termination of subsequent monitoring wells, which were terminated less than 10 m into clean strata. In all cases, the base of the drilled boreholes was installed with a competent bentonite seal to prevent further downward contaminant migration and targeted monitoring wells were installed within contaminant transport zones (coincident with fractures). Figure 11-15 shows the vertical contaminant profile detected within the first borehole drilled, alongside the targeted monitoring well that was installed. In the case of this borehole, the decision was made to install a monitoring well targeting the high TCE concentrations detected at 37 m bgl, which corresponded with the location of

a major fracture identified by the Core DFN and acoustic televiewer. The fractures with high concentrations located between 20-25 m bgl had also been targeted by an adjacent monitoring well installed during the preliminary site investigation in April 2015.

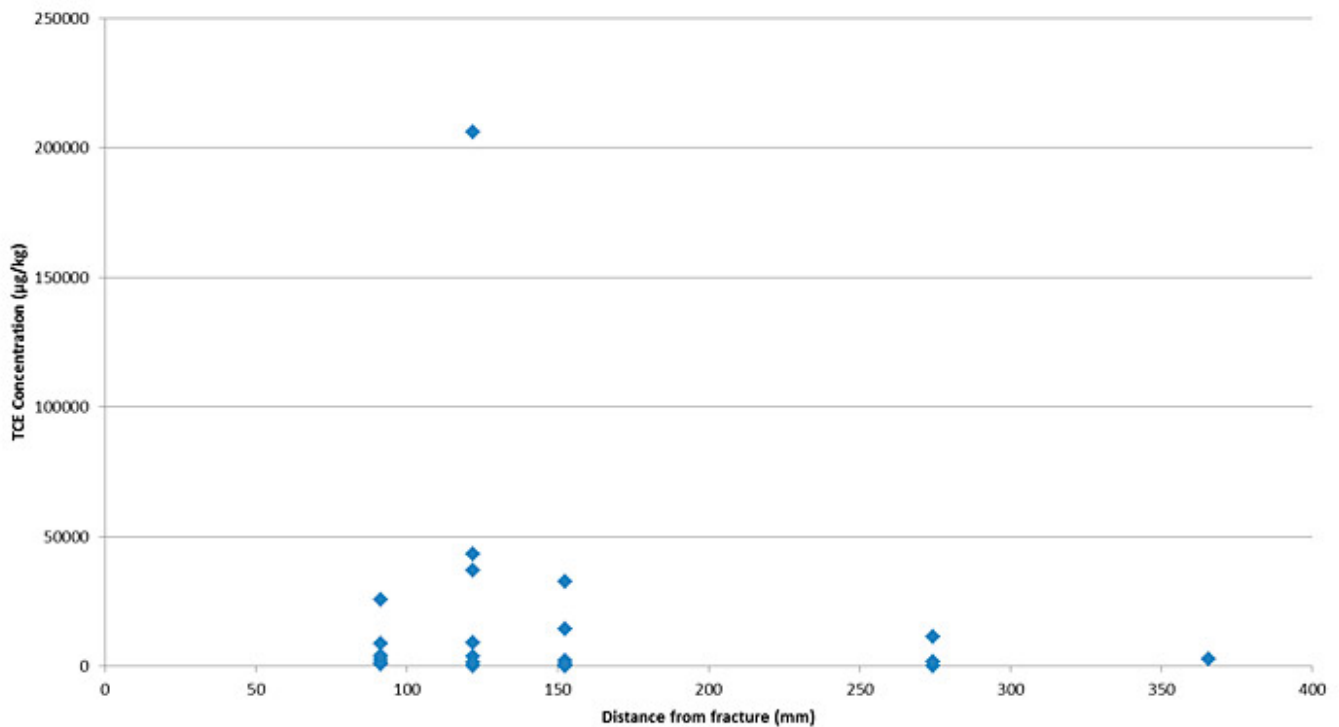
Figure 11-16. Plot showing TCE concentration in rock (µg/kg) vs distance of sample from fracture surface.

During the HRSC investigation, a total of 351 Core DFN rock samples were collected from a total of 186.8 m of linear rock cores, across four borehole locations. All samples were analyzed on site for VOCs. To further assist in interpretation, samples were also analyzed for physical properties (porosity, % moisture, bulk density) allowing the calculation of porewater concentrations. Comparison of porewater concentrations with groundwater concentrations indicates that elevated concentrations of TCE are present within the groundwater and fracture network and are also present within the rock matrix. Of the 351 samples collected, the majority were collected from fracture surfaces and located either immediately above or below a fracture. Furthermore, 73 samples were collected within the rock matrix away from fractures and of these, 30 contained concentrations of TCE above the laboratory limit of detection (LOD). Assessment of the 30 matrix samples with detections above LOD against the distance of these samples from the fracture surfaces suggests that TCE impacts have diffused a maximum of 365 mm into the slate bedrock matrix. This information suggests that TCE contained within the rock matrix represents a potential secondary source of contamination. The implications of the secondary source is considered as part of the remedial options appraisal for the site. Concentrations of TCE as determined via Core DFN and sample distance from a fracture surface are plotted in Figure 11-16.
