## 11.3 Characterization of Fractured Bedrock, United Kingdom

### HRSC Targets Impacts

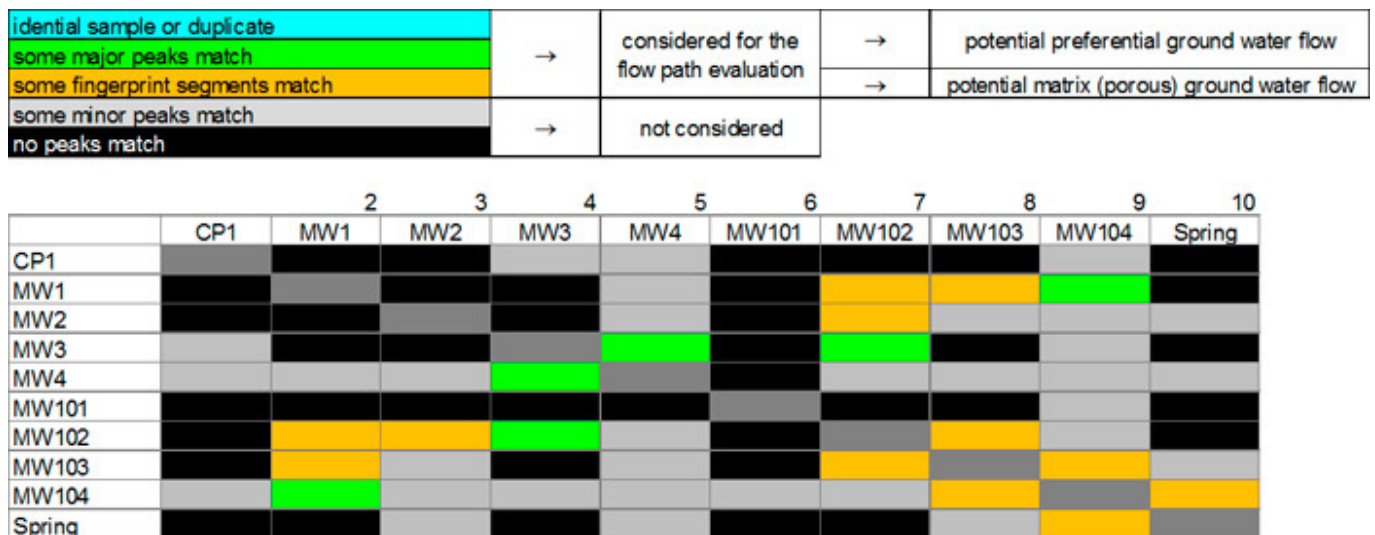
**Figure 11-14. Background fluorescence analysis results.**

The BFA identified potential hydraulic connections between monitoring wells located on the site and between the site and third party off-site receptors, as indicated in Figure 11-14. BFA uses the fluorescent properties of the organic content of groundwater samples to develop well-specific fingerprints, which are subsequently compared to predict potential hydraulic connections. The potential hydraulic connections identified support the likely TCE migration pathways identified within the fractured bedrock CSM and demonstrate the complexity of the subsurface.
